Reference Image Point 11, House Roof Corner, Nailaga.

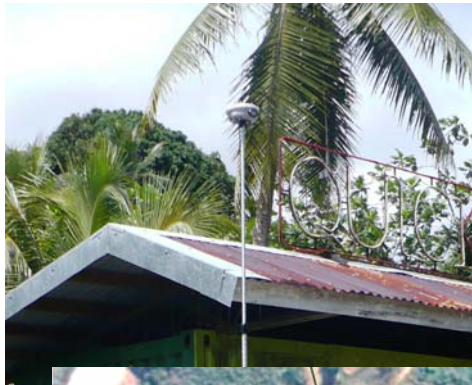
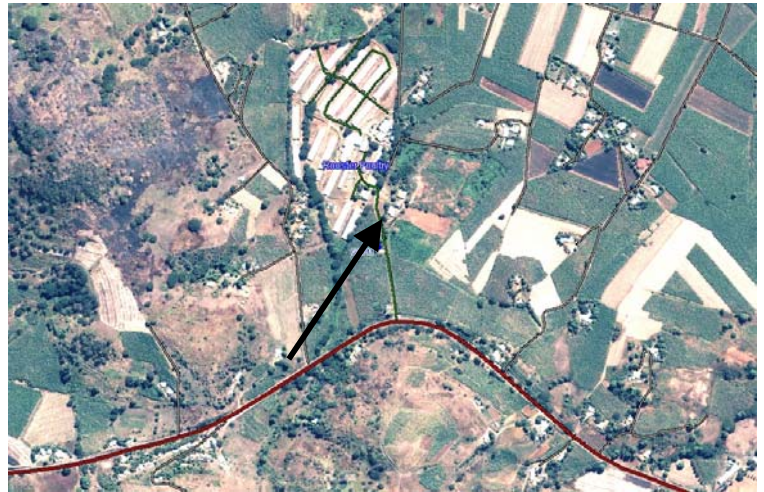
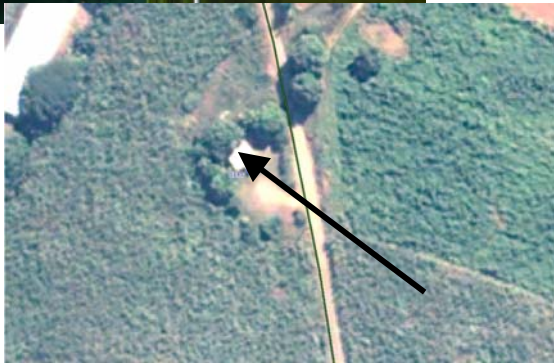
Reference Image Point 11 is near the Rooster Poultry Farm in the Sarava area. The access to the house is a vehicle road on the west of the Kings Road. The Rooster Poultry farm is located on the north of the house. The exact location of the point is the south western corner of the roof. The house is located on the west of the vehicle road.
