Reference Point 9, Roof Corner of house in Drasa Dam Road.

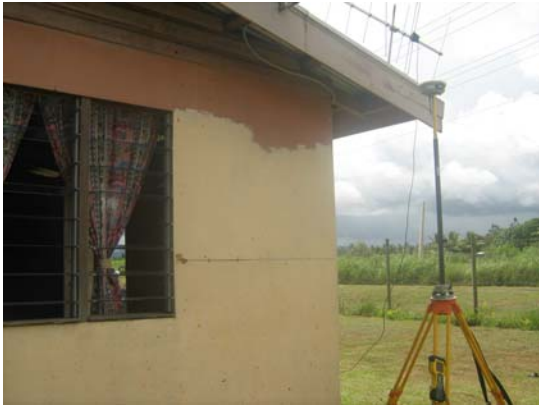
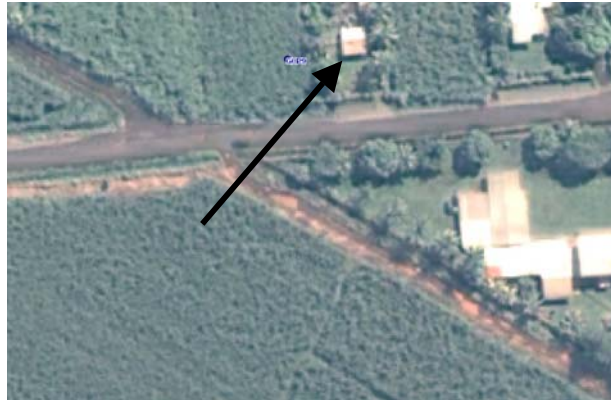
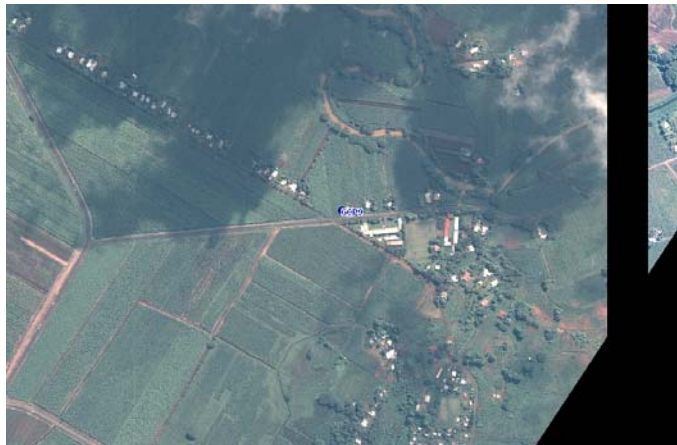
The reference point² is located in Drasa Dam Road which is on the western side of the Kings Road. The point is located on the south eastern corner of the house roof. The house is on the eastern side of Drasa Dam Road.

² There were not enough poles to elevate the rover antennae way past the roof. There is a high chance of multipath interference and therefore the average position for this point can be compromised.
