Reference Point 19, Lovu Hart, Lautoka.

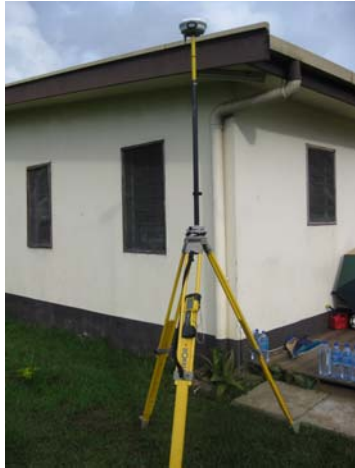
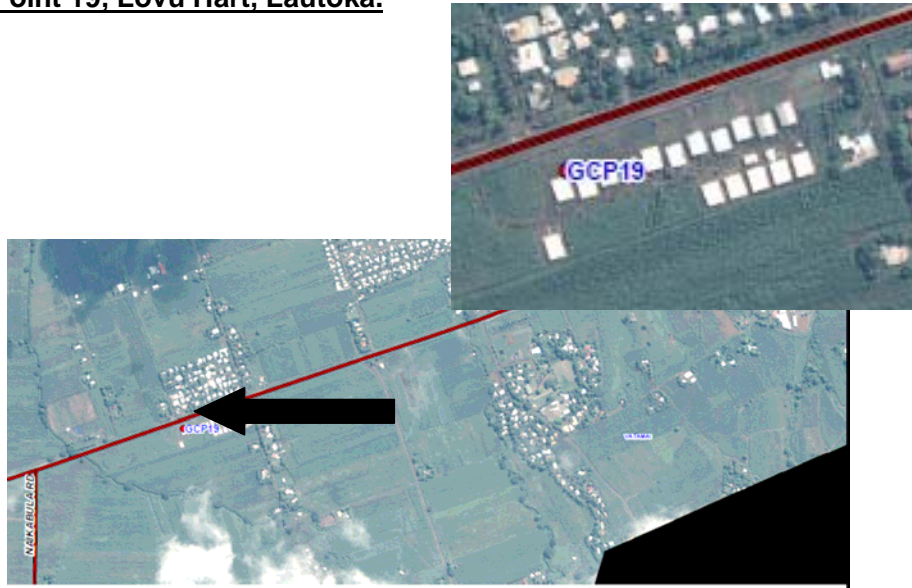
The reference point¹ is located in the HART (Housing Assistance Relief Trust) Community in Lovu which is south east of Lautoka City. The point is located on the north western corner of the roof. The HART Community is located on the western side of the Kings road.

¹ There were not enough poles to elevate the rover antennae way past the roof. There is a high chance of multipath interference and therefore the average position for this point can be compromised
